Contract #: 04-0120F4Cty: SF/ALA Rte: 80 PM: 13.2/13.9File #: 1.28**WELDING INSPECTION REPORT****Resident Engineer:** Siegenthaler, Peter**Address:** 333 Burma Road**City:** Oakland, CA 94607**Report No:** WIR-024432**Date Inspected:** 17-Jun-2011**Project Name:** SAS Superstructure**OSM Arrival Time:** 700**Prime Contractor:** American Bridge/Fluor Enterprises, a JV**OSM Departure Time:** 1530**Contractor:** American Bridge/Fluor Enterprises, a JV**Location:** Job Site**CWI Name:** Pat Swain and Jesse Cayabyab**CWI Present:** Yes No**Inspected CWI report:** Yes No N/A**Rod Oven in Use:** Yes No N/A**Electrode to specification:** Yes No N/A**Weld Procedures Followed:** Yes No N/A**Qualified Welders:** Yes No N/A**Verified Joint Fit-up:** Yes No N/A**Approved Drawings:** Yes No N/A**Approved WPS:** Yes No N/A**Delayed / Cancelled:** Yes No N/A**Bridge No:** 34-0006**Component:** SAS Tower**Summary of Items Observed:**

## WELDING INSPECTION REPORT

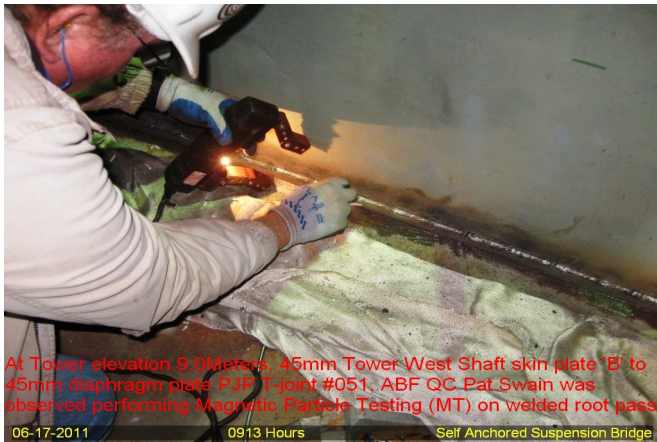
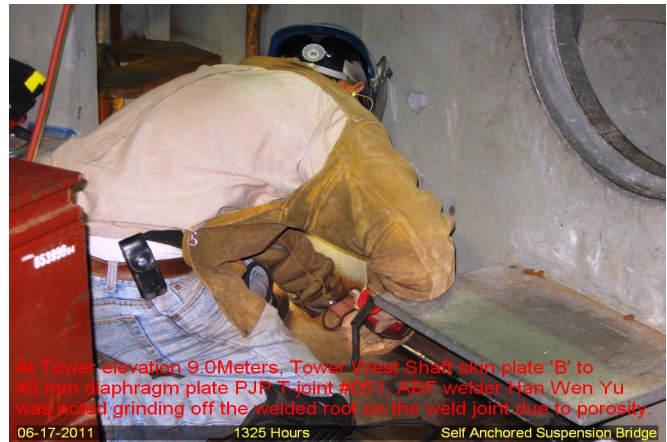
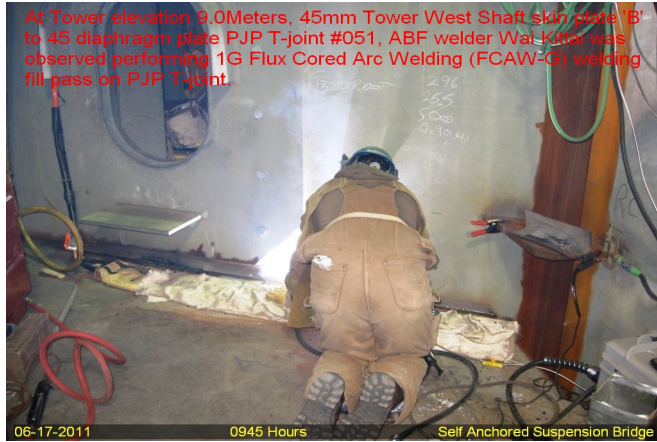
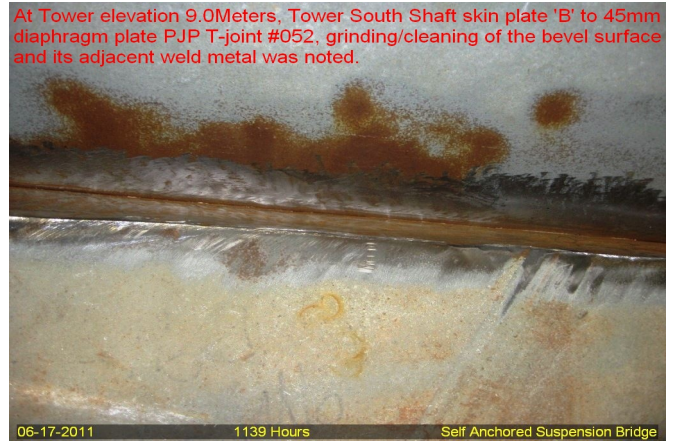
At Tower Base Skin Plate 'B' (45mm) to Diaphragm Plate (45mm) weld joint #051, this QA Inspector randomly observed ABF personnel Wai Kitlai continuing to perform production 1G welding on the Partial Joint Penetration (PJP) of T-joint between the 45mm thick skin plate and 45mm thick diaphragm plate. The welder was using the dual shielded Flux Cored Arc Welding (FCAW-G) with E71T-1M, 1/16" diameter wire electrode and implementing Caltrans approved Welding Procedure Specification (WPS) ABF-WPS-D15-3160-1. This QA Inspector observed ABF personnel using Miller Proheat 35 Induction Heating System to preheat the plates being welded prior to and after welding. This QA Inspector observed QC Inspector Pat Swain using a Fluke infra red temperature gauge to verify the preheat temperature of more than 225°F. This QA Inspector performed a verification of the welding parameters and observed 285 amperes and 24.7 volts with a travel speed of 388 mm per minute with equivalent heat input of 1.08 Kj per mm. The welding appeared to comply with Welding Procedure Specification (WPS) ABF-WPS-D15-3160-1. At the end of the shift, cover pass welding was partially completed along the length of the joint and should continue tomorrow. ABF personnel were noted covering the weld with heater blanket in preparation for the three hours holding of preheat temperature of more than 225°F as required. ABF personnel were using Miller Proheat 35 Induction Heating System to hold the preheat that was programmed to shut off after three hours.

After the electro slag welding (ESW) completion of the transition weld joint E-044 at location 'B', ABF personnel were noted dismantling the Hilti MI-90 strut column and its bracket that were used to hold the water cooled weld shoes and moved them to the next new location weld joint E-045 at location 'F' which is scheduled to be welded June 18, 2011. ABF personnel were noted erecting the Hilti MI-90 strut columns in position in preparation for the next ESW. Some personnel were noted tack welding the brackets that support the Hilti MI-90 strut column to the strong back supports while some personnel were noted wire cleaning the surface of the joint and its adjacent metal.

ABF QC Jesse Cayabyab and this QA performed a joint fit up verification on the T- joint E-045 at location 'F' to be welded tomorrow. The measured root gap from bottom to top was noted 18mm minimum and 22mm maximum. There was no lesser than 16mm nor more than 25mm root gap noted from the bottom to the top of the T-joint. With the measurements that were taken during the fit up verification, the fit up of the weld T- joint was deemed in compliance to the contract requirements.

Other related welding activities noted at the tower base include grinding on the groove bevel surface of PJP T-joint #052 Tower South Shaft skin plate 'B' 45mm thick to 45mm thick diaphragm plate in preparation for the next welding. The groove bevel surface grinding was completed and ready for FCAW-G welding.

Grinding off the partial welded root on Tower Base Skin Plate 'B' (45mm) to Diaphragm Plate (45mm) weld joint #051 due to porosity was noted ongoing.
